TS-PIC-89790
September 1989

AERIAL PHOTOGRAPHIC ANALYSIS OF THE MADISON MINE COMPLEX Fredericktown, Missouri

EPA Region 7

Superfund

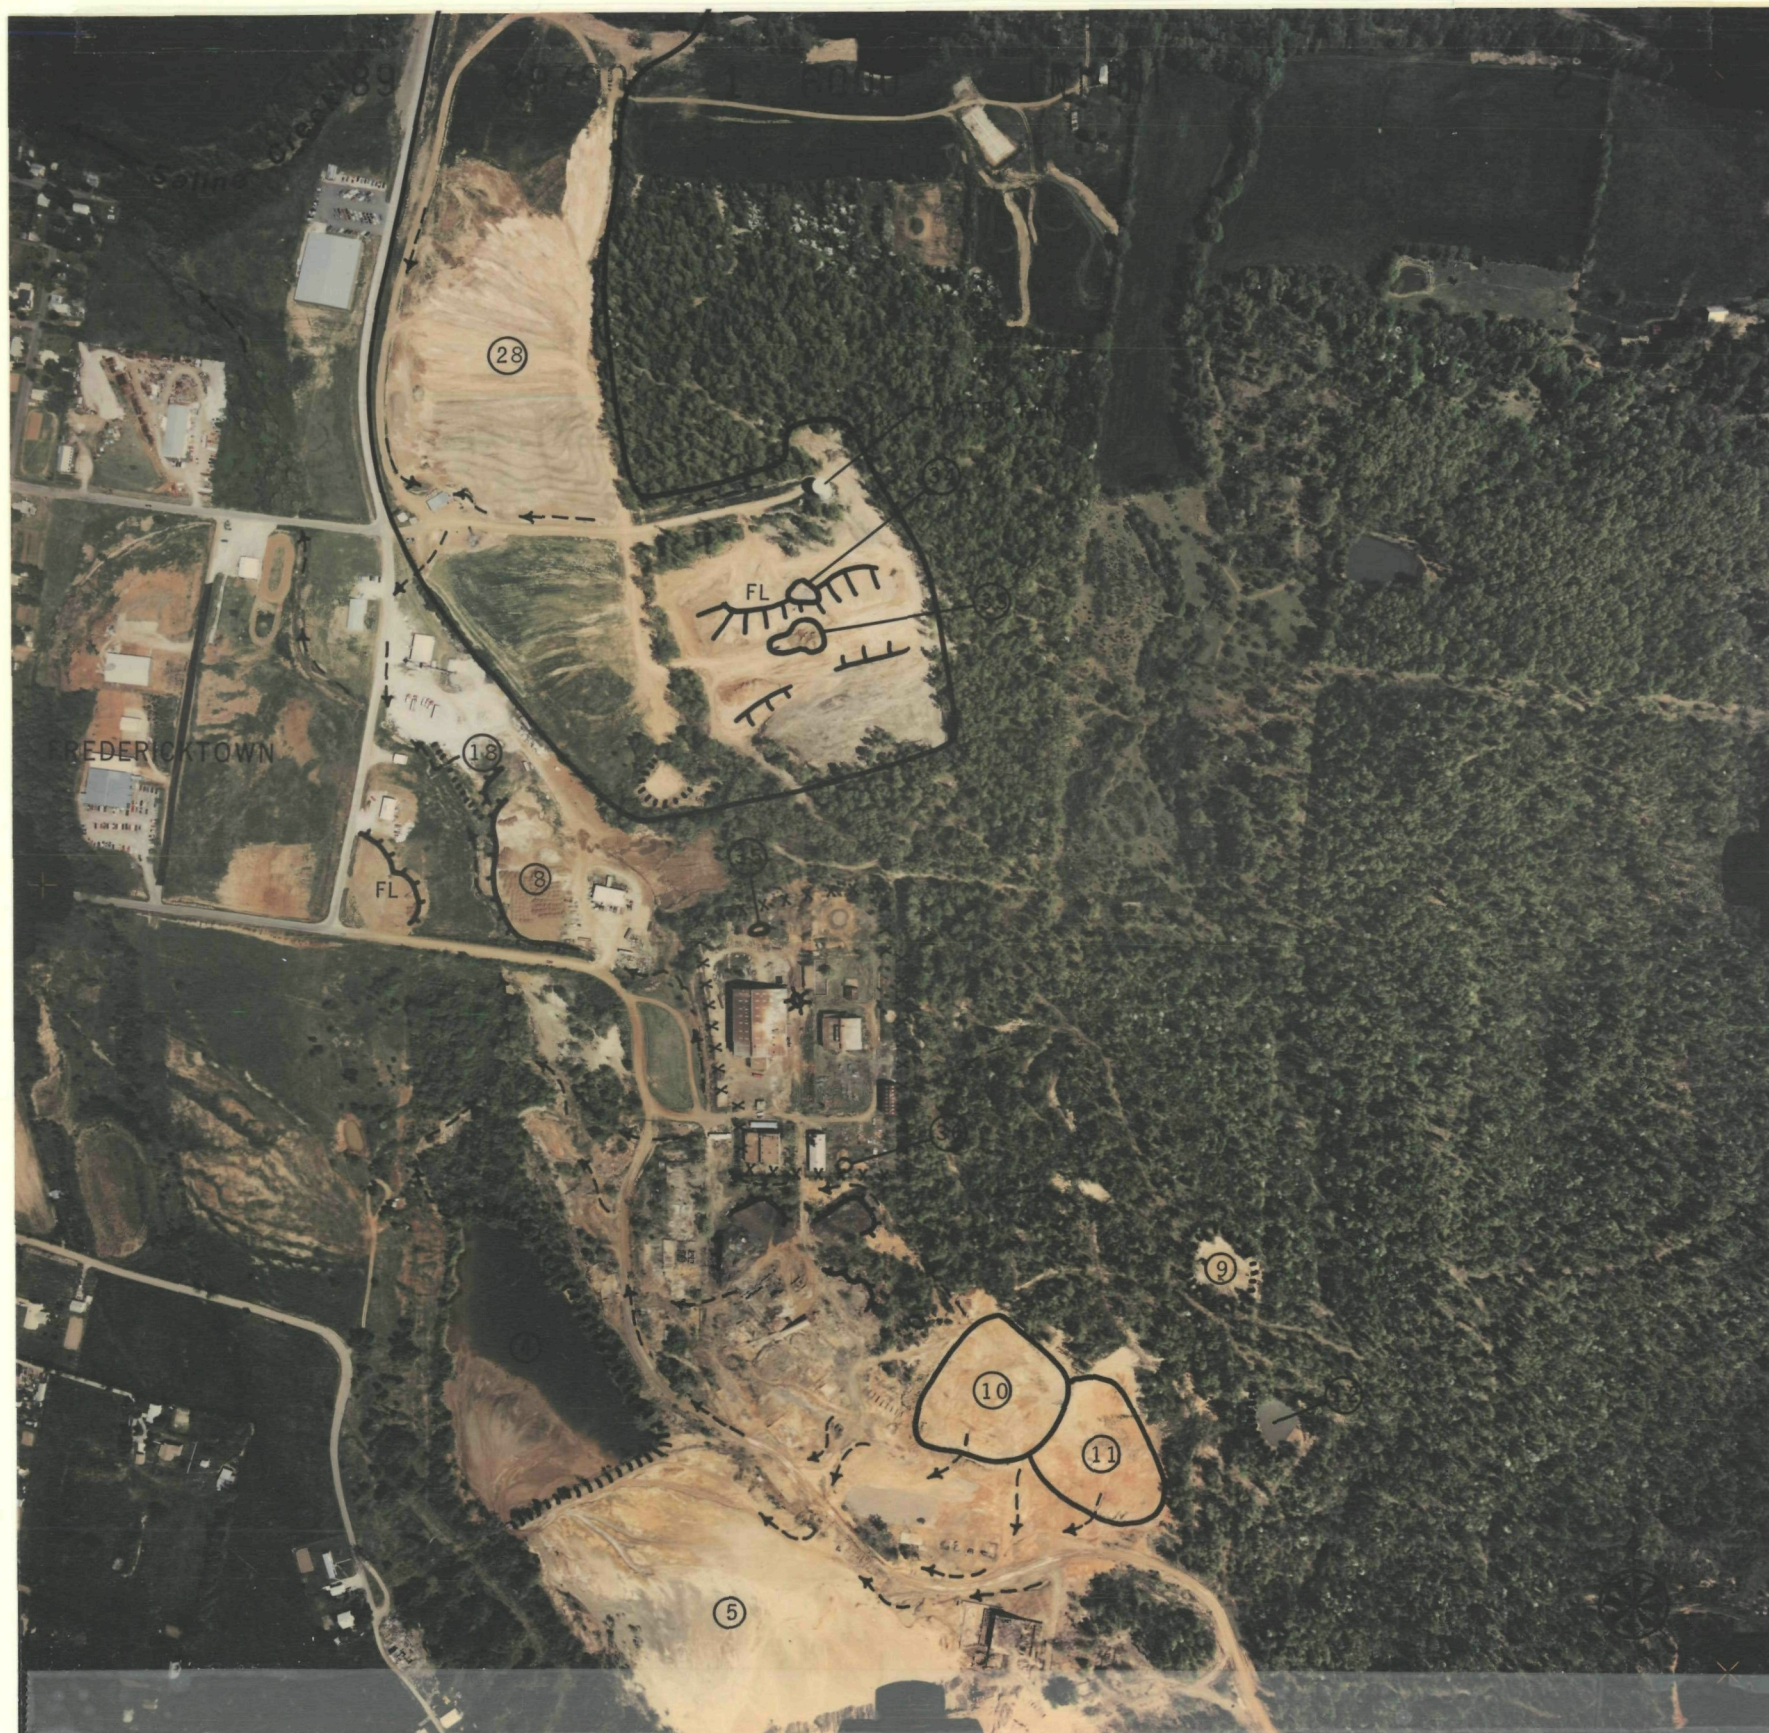
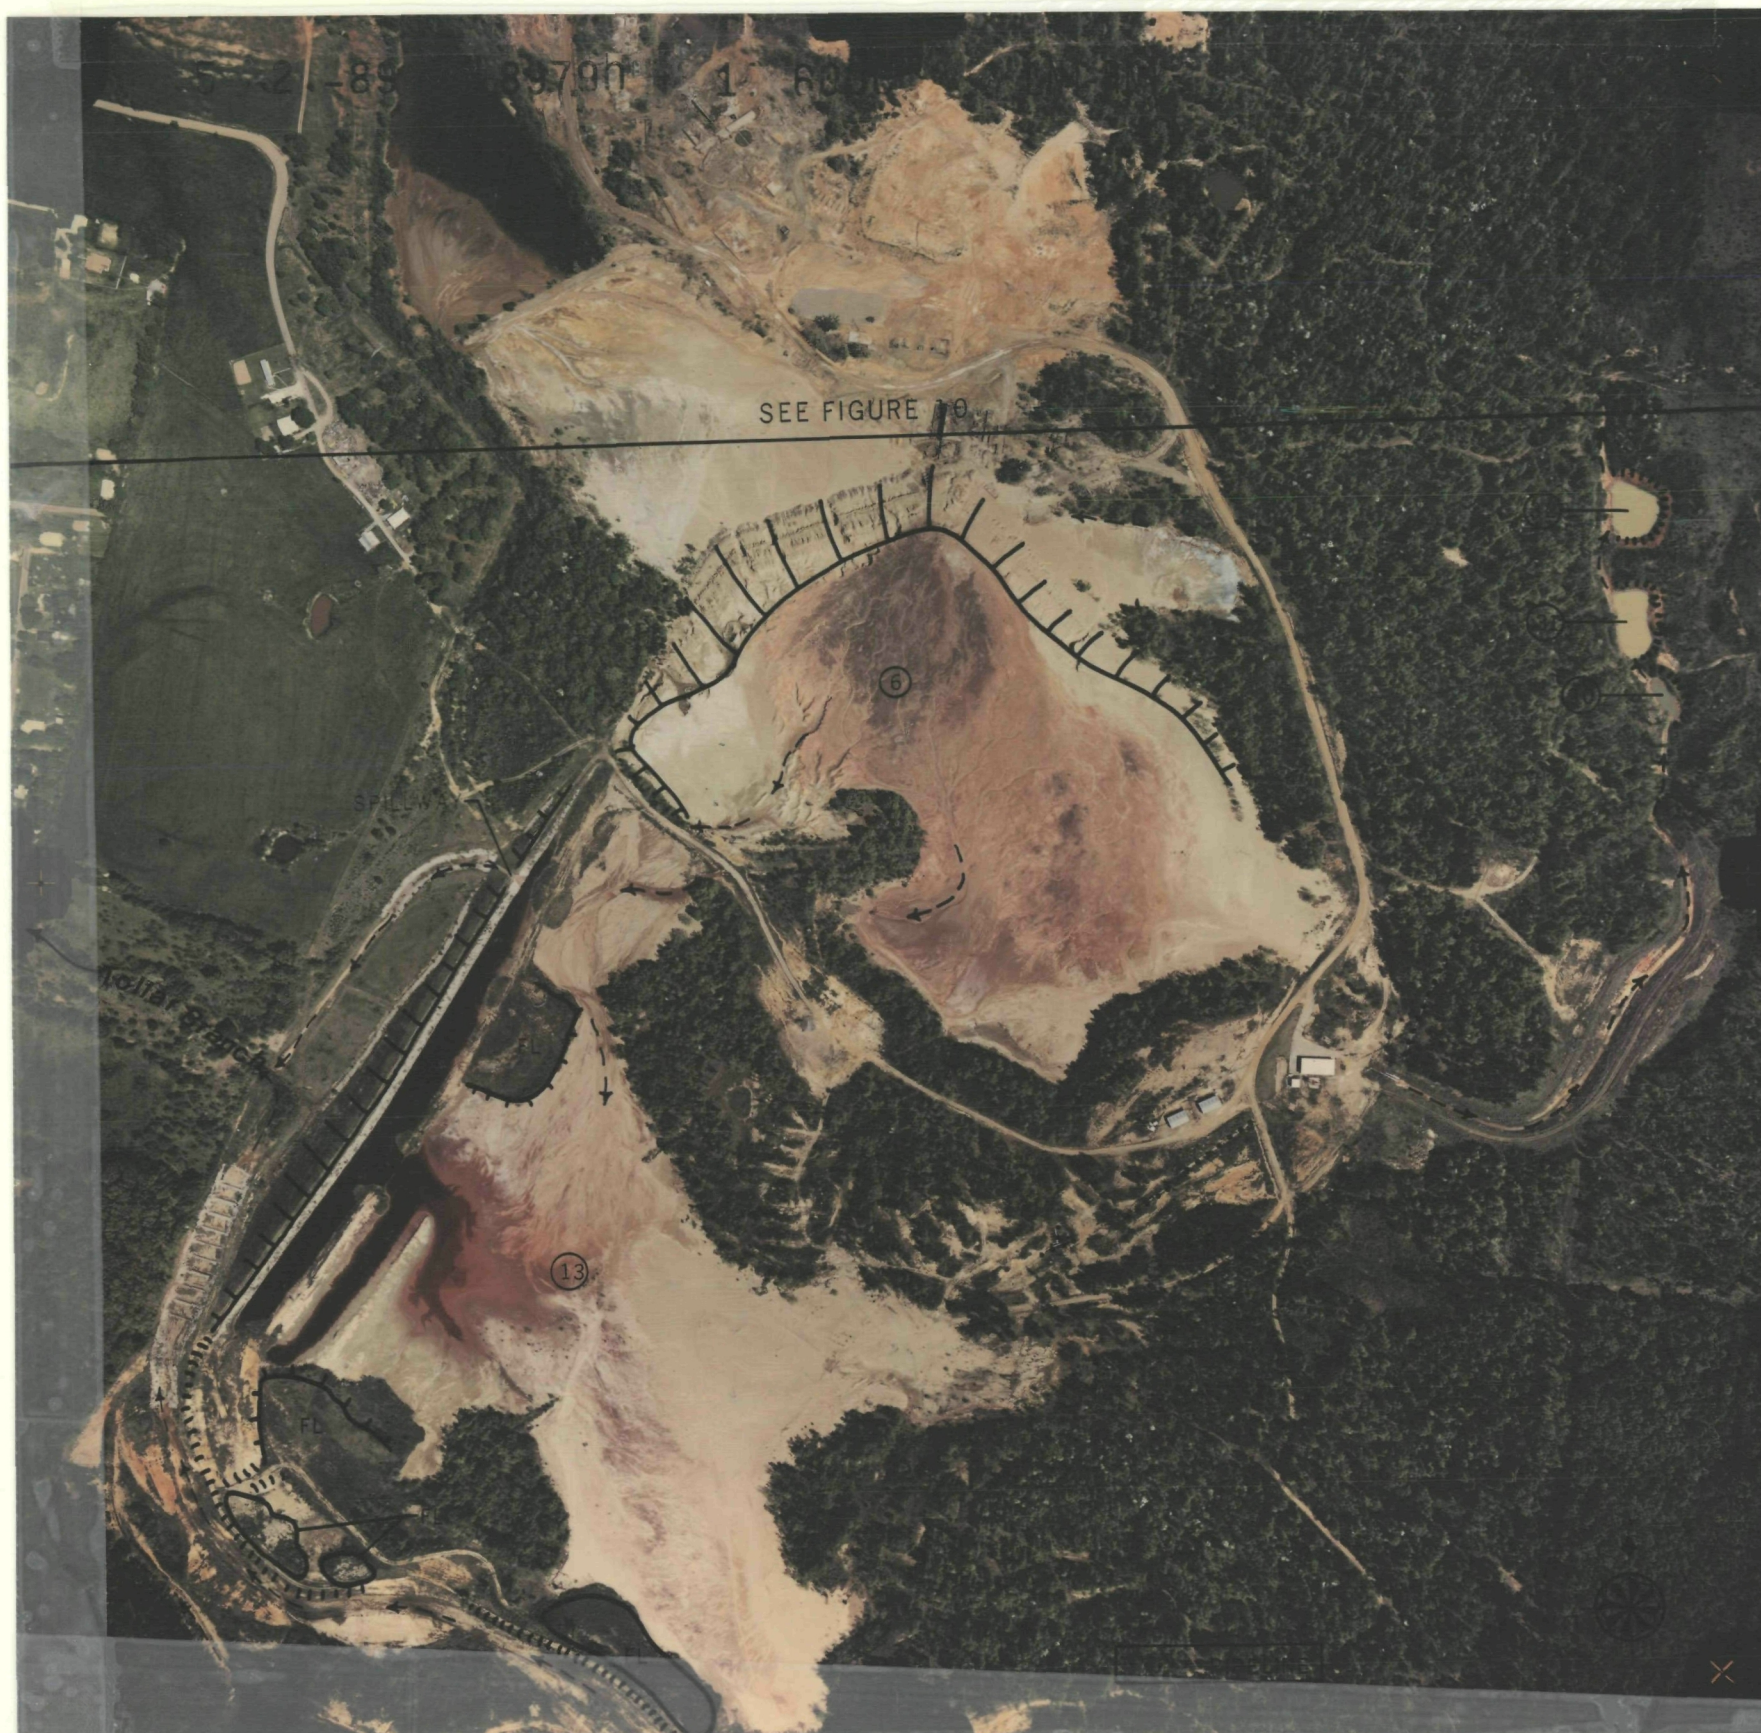
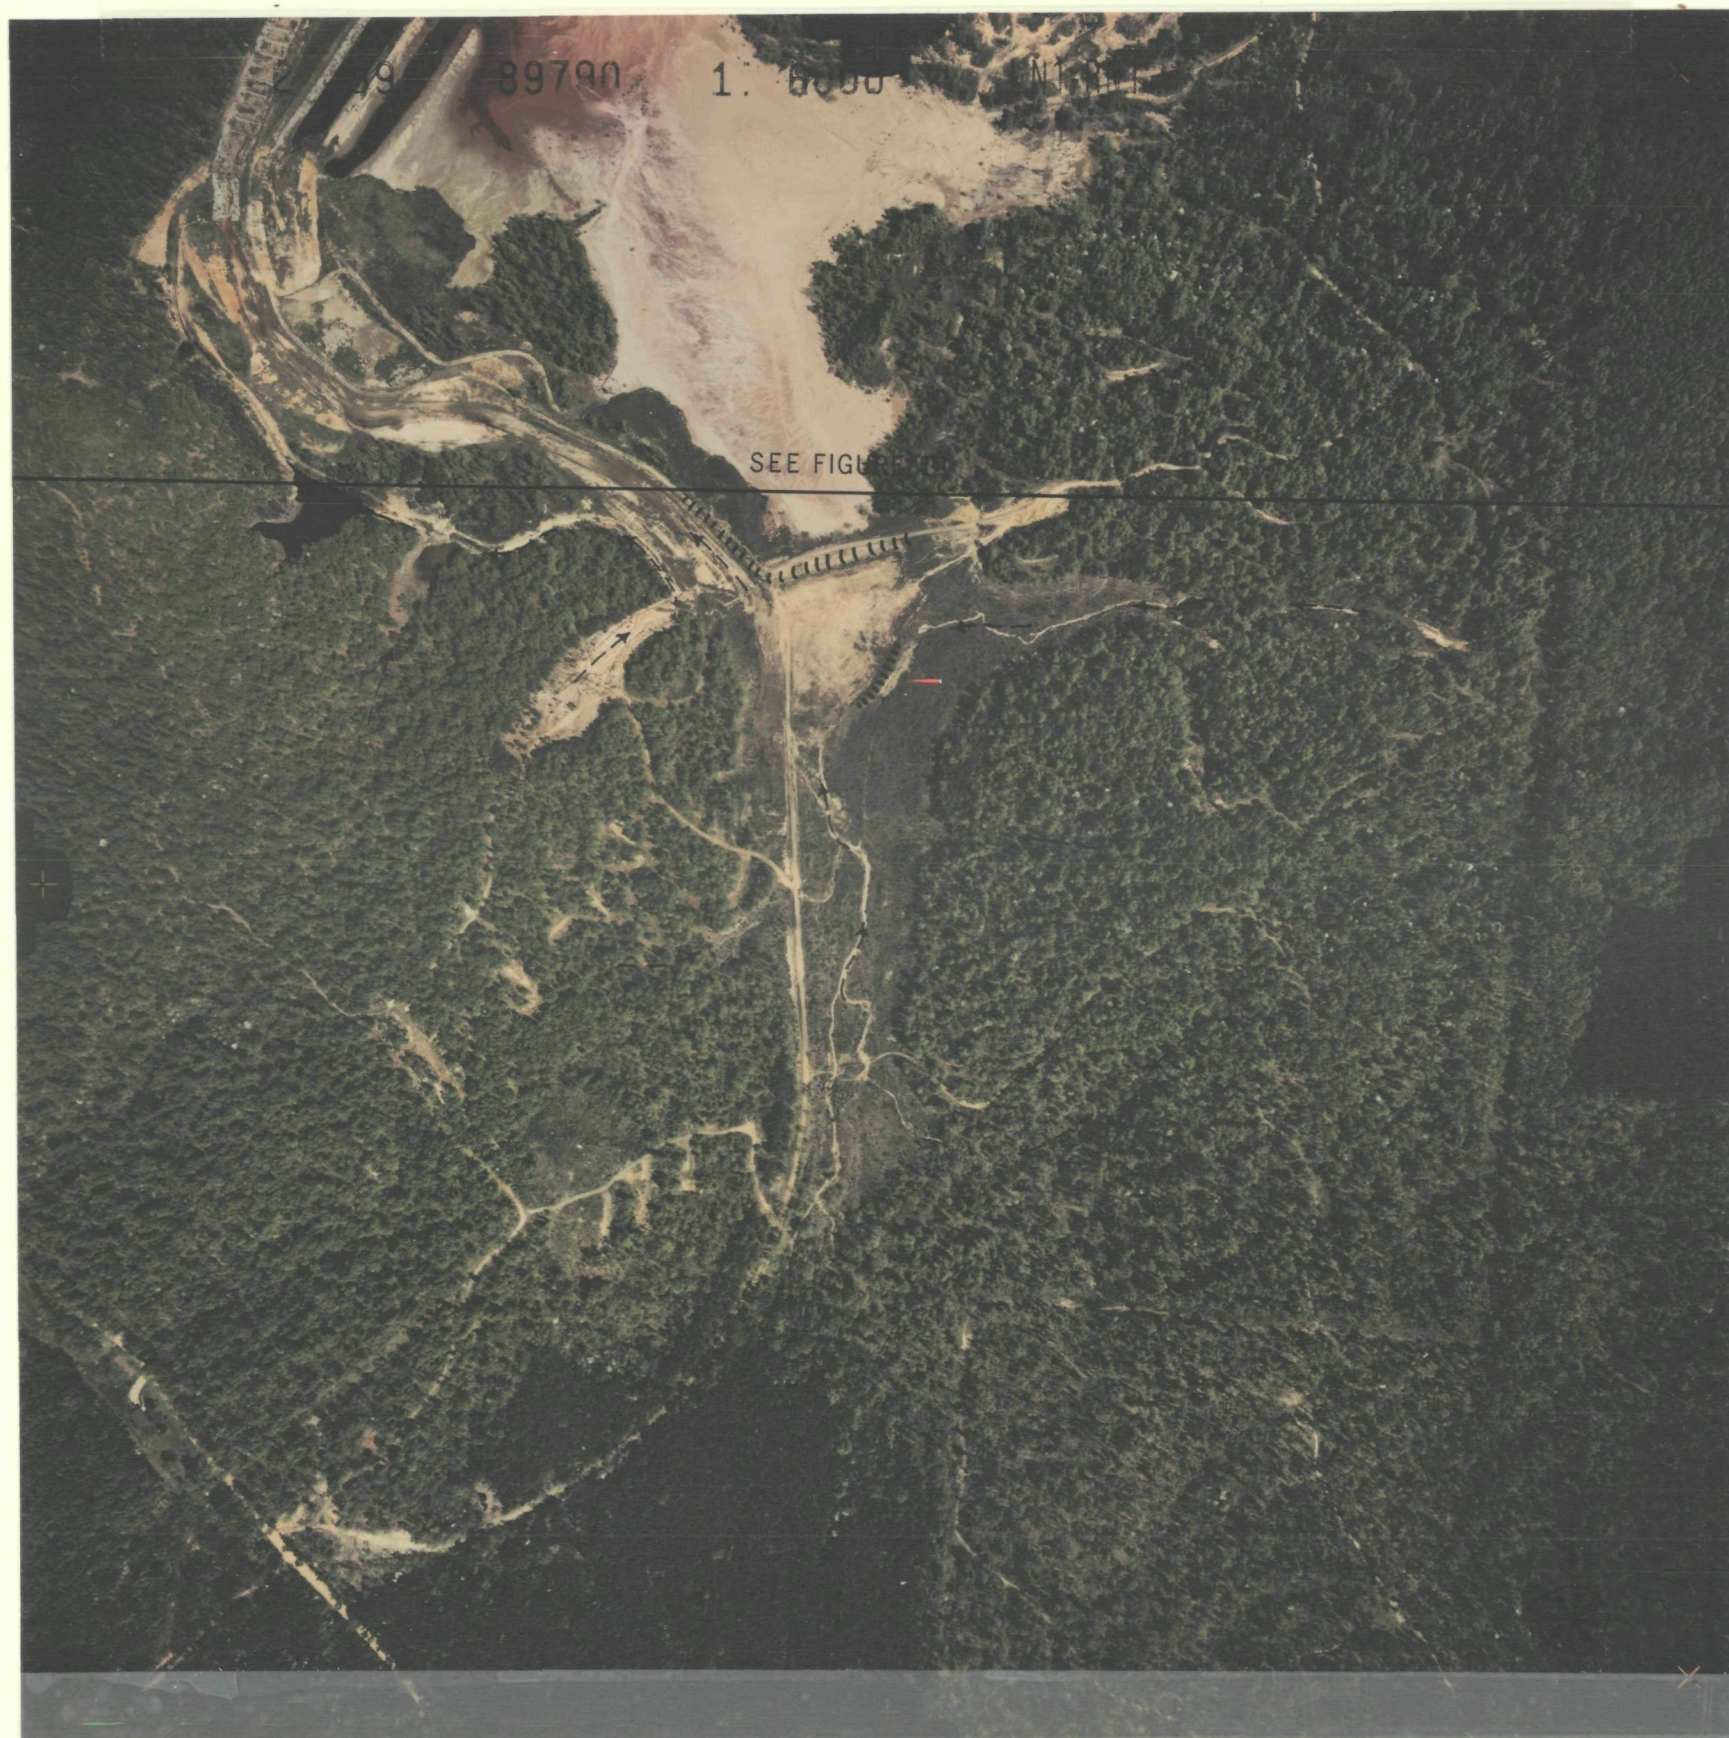
No significant changes were observed at the tailings pond (Annotation 4), tailings (Annotation 5) or the ponds located at Annotations 9 and 12 since the photo coverage of April 18, 1984 (Figure 9). The trenches previously located in Annotation 28 have been filled and the south portion of the area revegetated. The hillside east of the revegetation has been cleared and there is a backhoe and dozer digging a pit in the excavation at Annotation 33. Debris has been dumped on top of the fill at Annotation 34. Annotation 18 is the previous location of an impoundment. There is white sediment in the cut that has been made through the containment wall and in the intermittent stream leading north to Saline Creek. The impoundment is partially filled with sand and fill dirt. Annotation 8 is the previous location of an impoundment that has been completely filled. Annotations 35 and 36 show the locations of two newly excavated pits. The containment walls of the ponds previously located at Annotations 10 and 11 have been removed and there are numerous small rills and gullies passing through this area and leading toward the intermittent stream.

There is no significant change noted at the tailings located at Annotation 6 which displays extensive erosion along its northern face and along the southern portion leading into the tailings at Annotation 13. There are five areas around the perimeter of the tailings of Annotation 13 where fill material has been dumped and has now revegetated. The three holding ponds (Annotations 30, 31, and 32) located along the drainage ditch on the eastern side of the facility all contain a greenish colored murky liquid.
